The building at 120 The Terrace is not considered earthquake-prone under the current legislation.

Table IEP-1 Initial Evaluation Procedure Step 1

Building Name:	120 The Terrace, Quest Wellingtonian	Ref.	WCC 4462 Lot#1
Address:	Wellington Central	By:	Beca - APG
		Date:	17/01/2007

LEVEL 1 RAPID SEISMIC ASSESSMENT REPORT

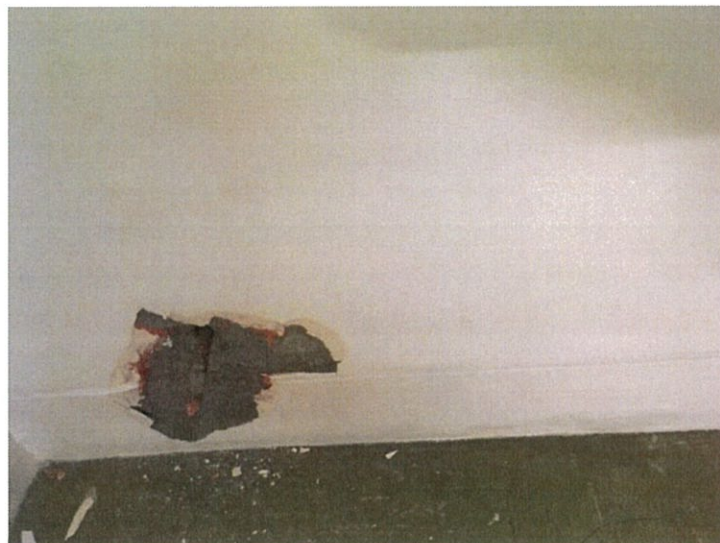
A blow out of plaster where a steel rod had pierce through was observed, it was deemed that this was pre-existing and had just been pushed through more. Also some damage was observed to the rear corner of the stair core which seems to have pounded with the adjacent building. This was difficult to observe in detail the extent of the damage.

Steel connection rod penetrating through concrete wall

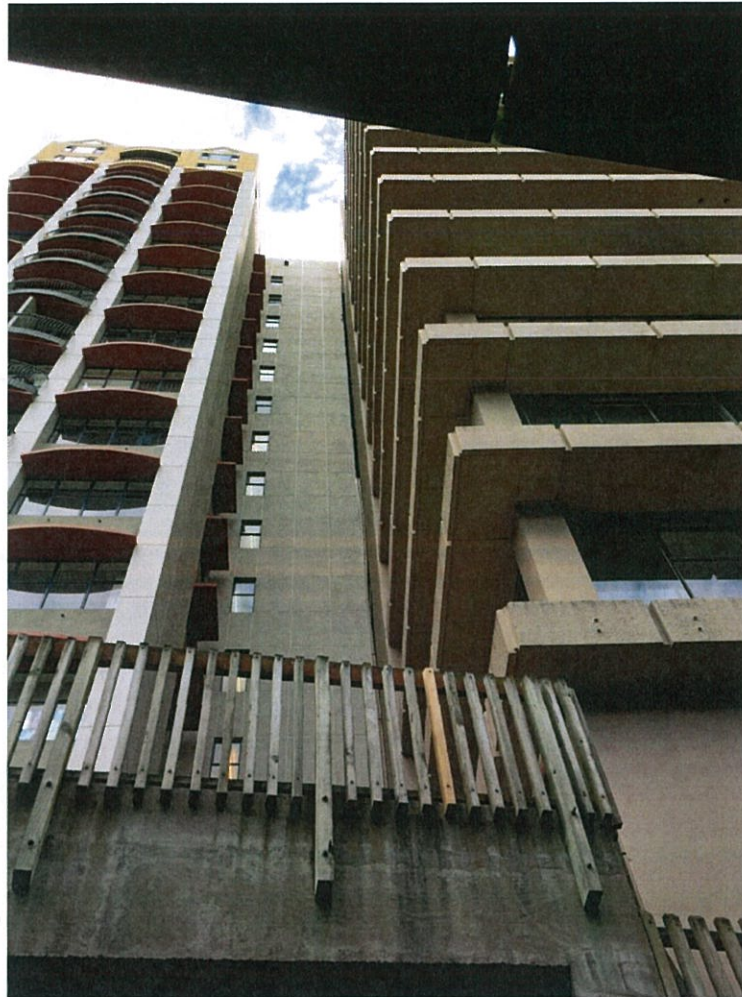
Damage to the corner of the building from pounding with adjacent building
