ADDENDUM TO SEISMIC ASSESSMENT
FOR
BODY CORPORATE 88141
2 OHIRO ROAD, TE ARO

CLIENT Body Corporate 88141
PROJECT ADDRESS 2 Ohiro Road, Te Aro
DTCE PROJECT NUMBER 216513
DOCUMENT NAME 216513-RP-001

REVISION HISTORY	REVISION	DATE	REASON
	A	6/9/18	Addendum to June 2013 report

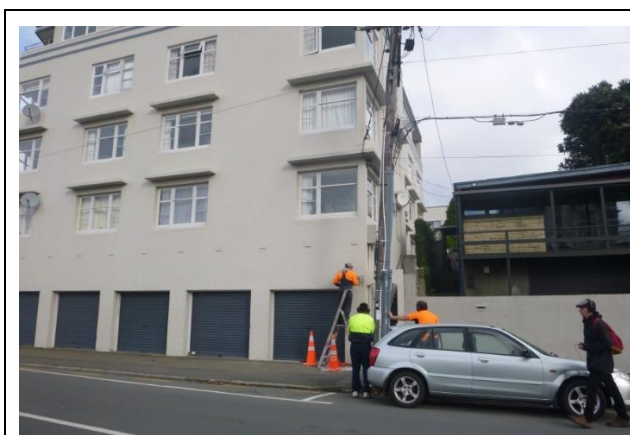
On the 5 June 2018, an invasive investigation was carried out at 2 Ohiro Road. The investigation involved the breaking out of a localised section of concrete to determine whether the reinforcing bars were hooked at the ends. A section of concrete was broken out at the beam-column joint above the north-western corner garage. The results of the testing conclusively show that the reinforcing forcing bars have been hooked as per the original drawings.

Figure 1: Area of investigation

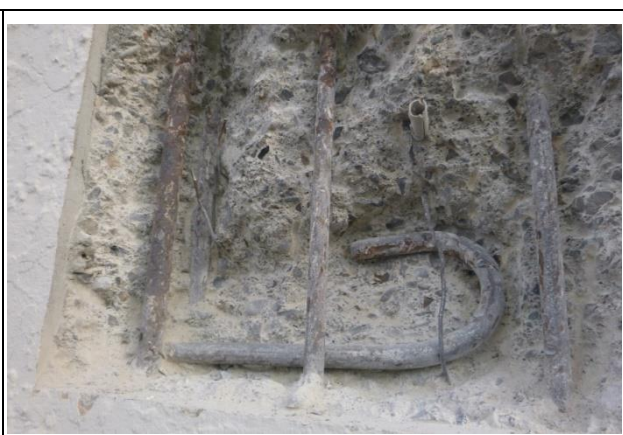
Figure 2: Hook in reinforcing bar found

As a result of the invasive investigation, we presume the building was built as per the original drawing. Once establishing that the reinforcing bars have been hooked at the ends, we were able to improve our assumption about the lap length of the reinforcing bars from our original calculations. We have updated our calculations and the results are as follows
