The building at 120 The Terrace is not considered earthquake-prone under the current legislation.

Table IEP-1 Initial Evaluation Procedure Step 1

Building Name:	120 The Terrace, Quest Wellingtonian	Ref.	WCC 4462 Lot#1
Address:	Wellington Central	By:	Beca - APG
		Date:	17/01/2007

LEVEL 1 RAPID SEISMIC ASSESSMENT REPORT

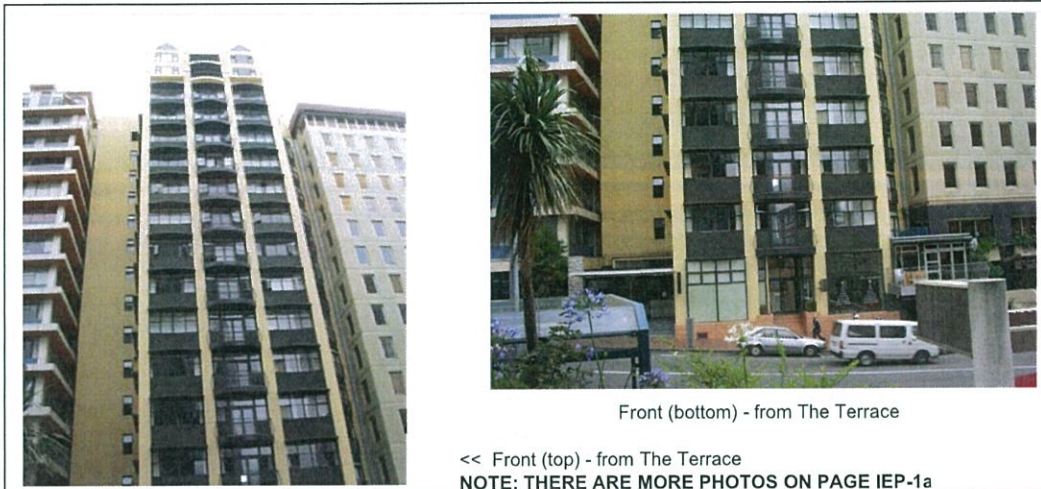
1.1 Photos (attach sufficient to describe building)

1. The Quest Wellingtonian serviced apartments. Constructed in 1967.
2. RC frame.
3. Rectangular in plan with two wings (on both sides). Wings have RC walls. Carpark levels at rear.
4. 18-19 story high (16 storey above the terrace and 2-3 below). Slightly higher floor height at The Terrace level
5. Well maintained, no signs of significant deterioration observed
6. Potential pounding on each side in the longitudinal direction, buildings are similar heights, floors not aligned
